DESCRIPTIVE REPORT

Type of Survey Hydrographic

Field No. S0-2358 Office No. H-8429

Locality North Tampa Bay

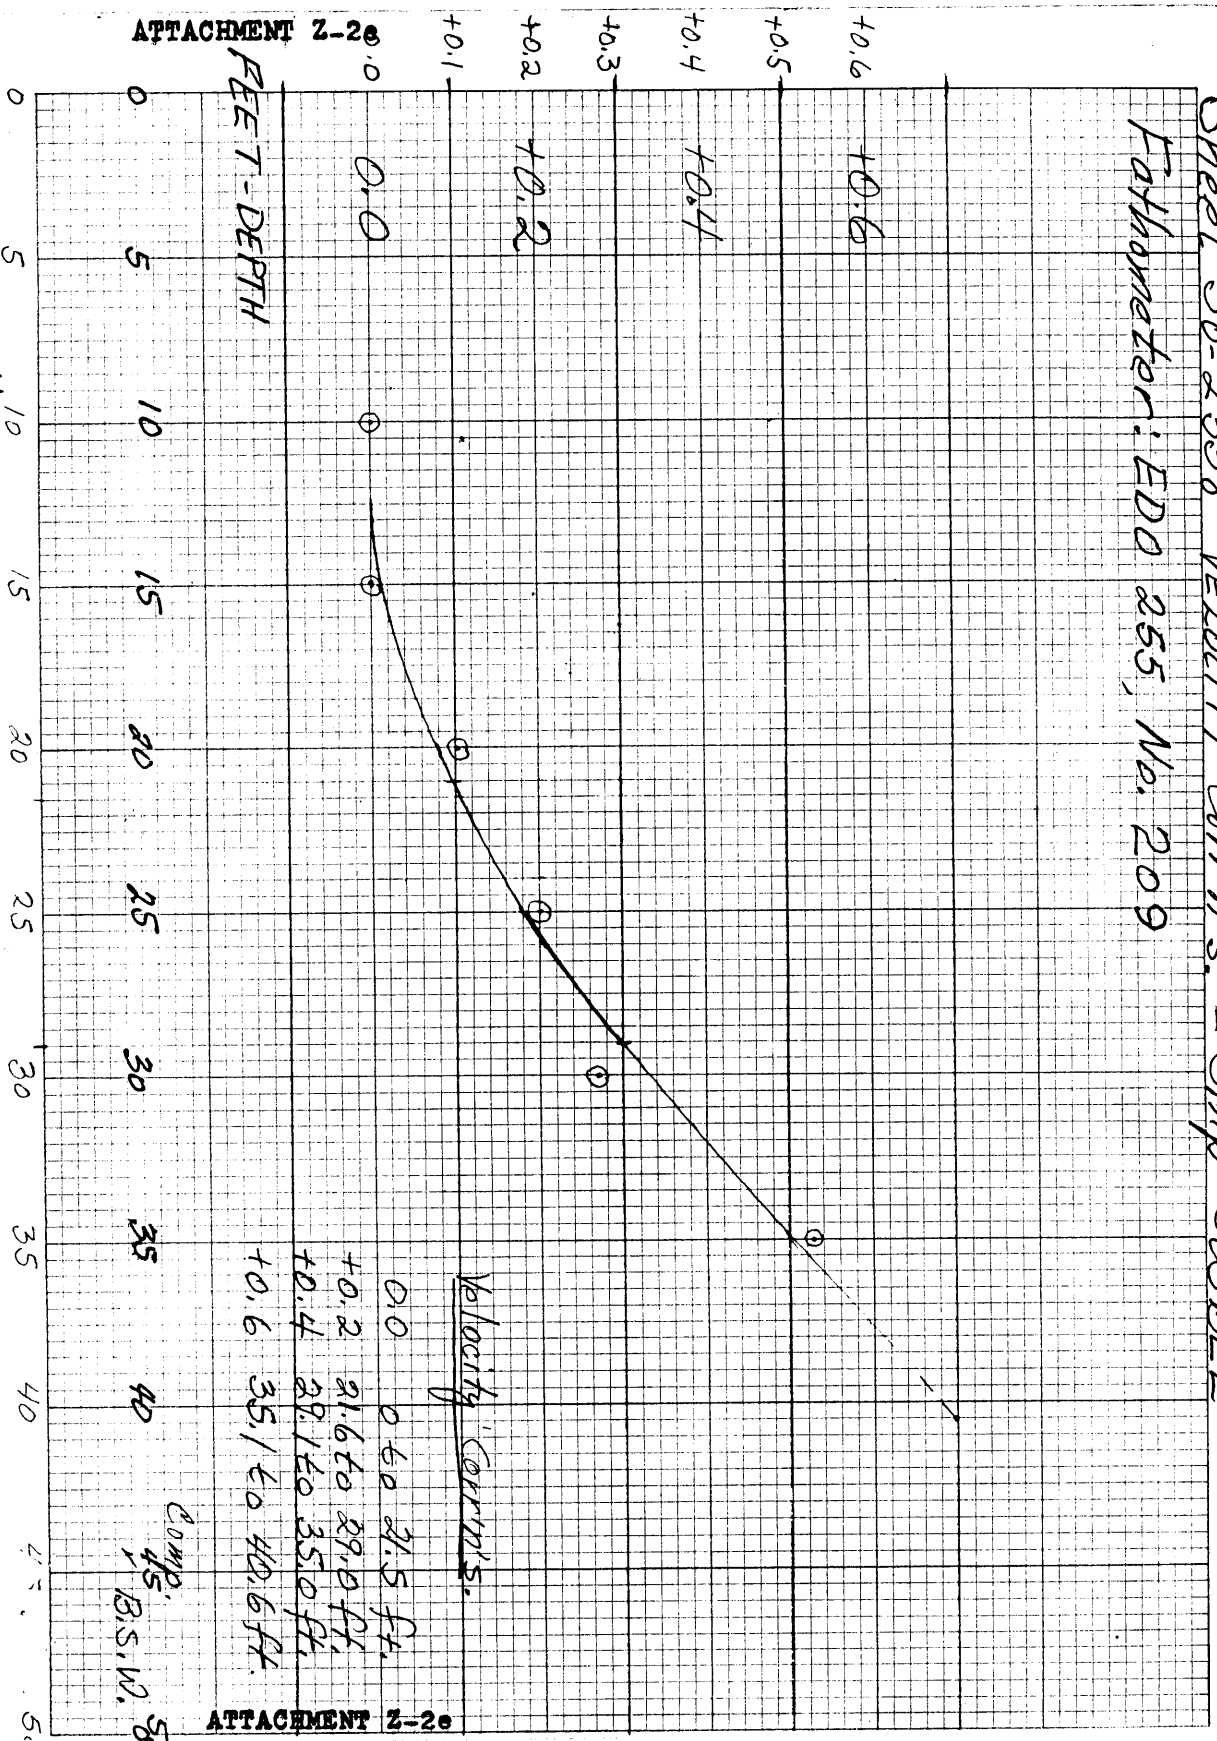
Sheet 50-2358 Velocity Cor'n's. - Ship SCSBEE
 Fathometer: EDO 255, No. 209

Velocity Cor'n's.
 0.0 0.60 21.5 ft.
 +0.2 21.6 to 29.0 ft.
 +0.4 29.1 to 35.0 ft.
 +0.6 35.1 to 40.6 ft.
